**RE: QUARTERLY PROGRESS REPORT FOR THE AVTEX FIBERS SUPERFUND SITE FOR THE PERIOD  
APRIL 1 THROUGH JUNE 30, 2019**

# Quarterly Inspection Report

**Quarterly Inspection Report Photographic Log**  
**Avtex Superfund Site**  
**Front Royal, Virginia**

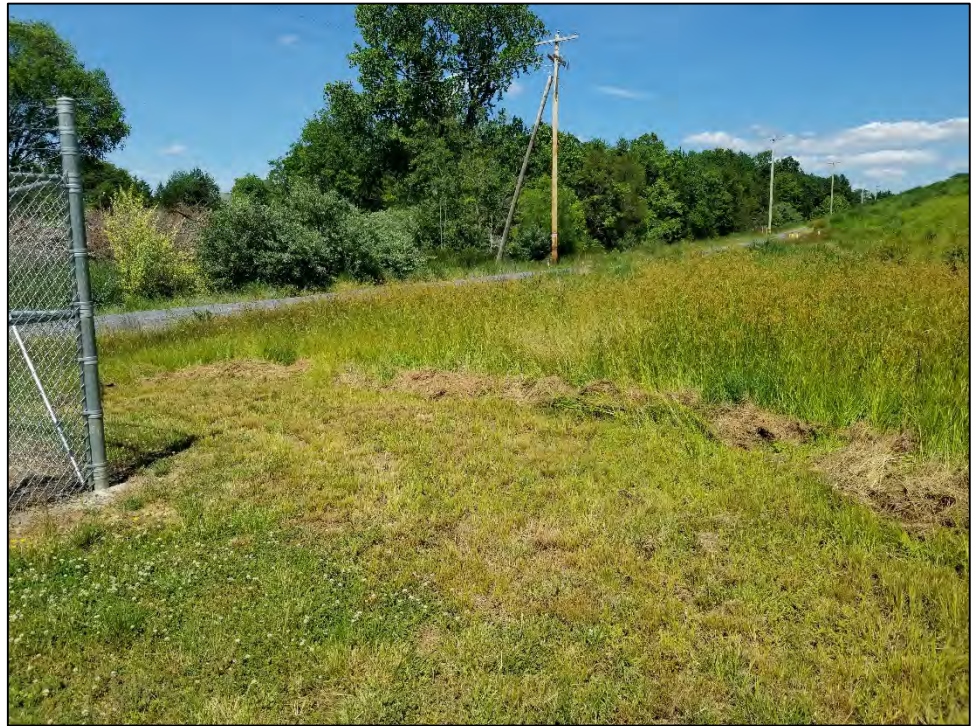
**Photo Number:** 1

**Photo Description:** 20' x 40' area of former standing water adjacent to LS-2 (Dry).

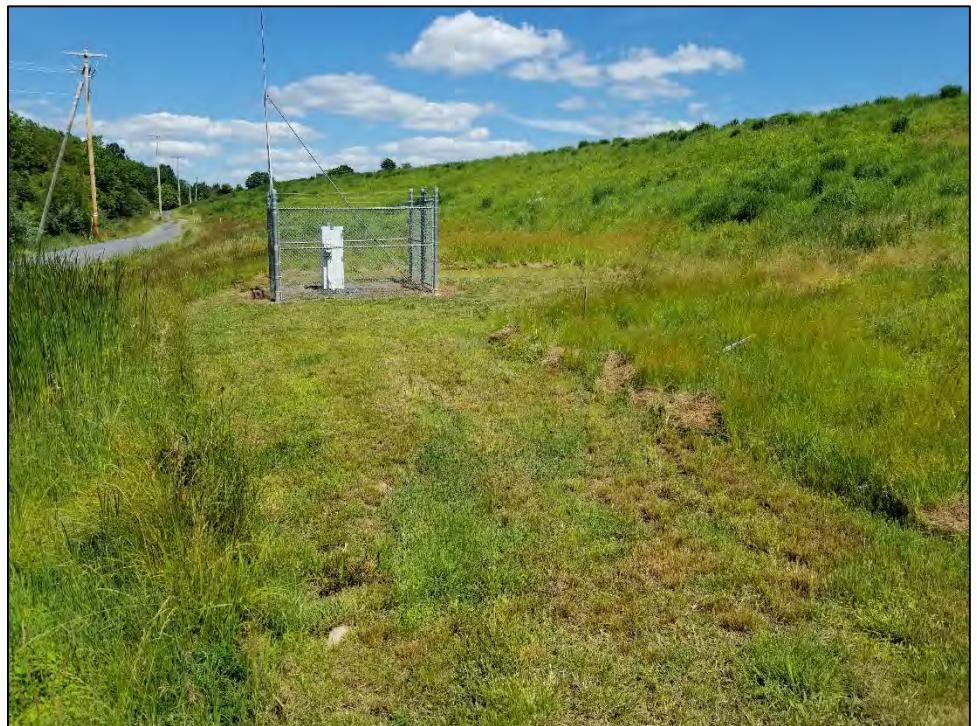
**Photo Number:** 2

**Photo Description:** 20' x 40' area of former standing water adjacent to LS-2 (Dry).

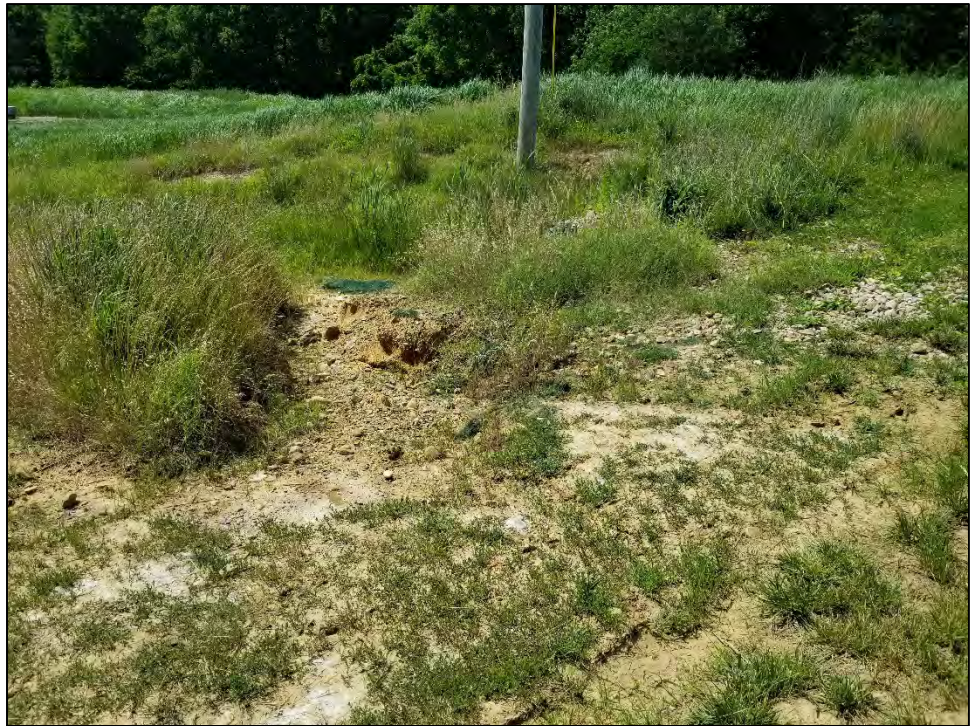
**Photo Number:** 3

**Photo Description:** Rills forming on access road to LS-1 west of VB-4, 5, & 6.

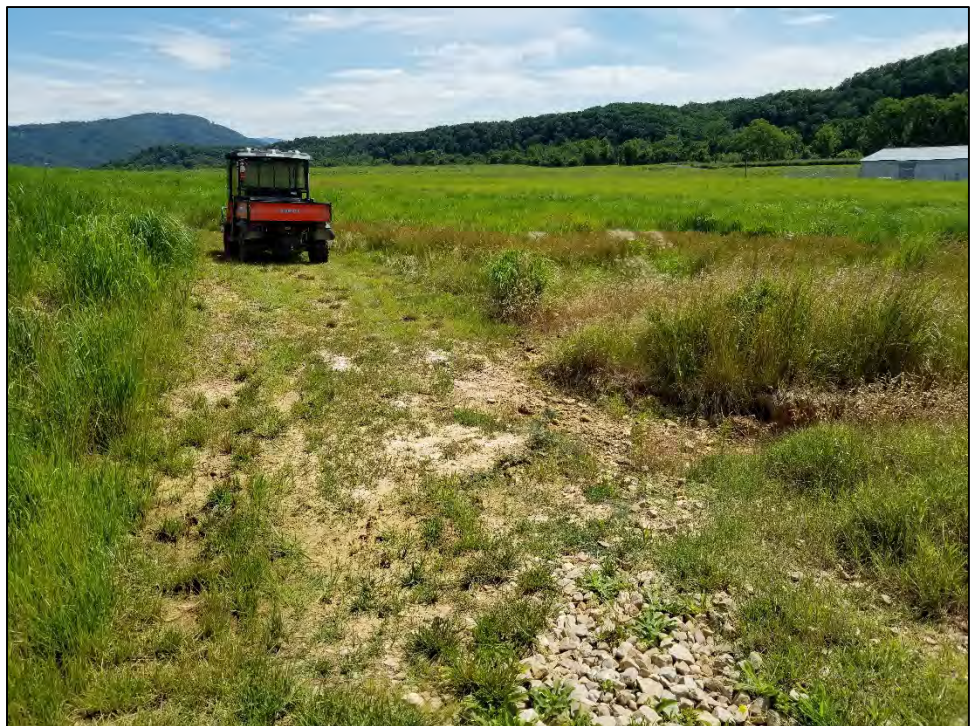
**Photo Number:** 4

**Photo Description:** Former area of standing water at access path to LS-1 west of VB-4, 5, & 6.

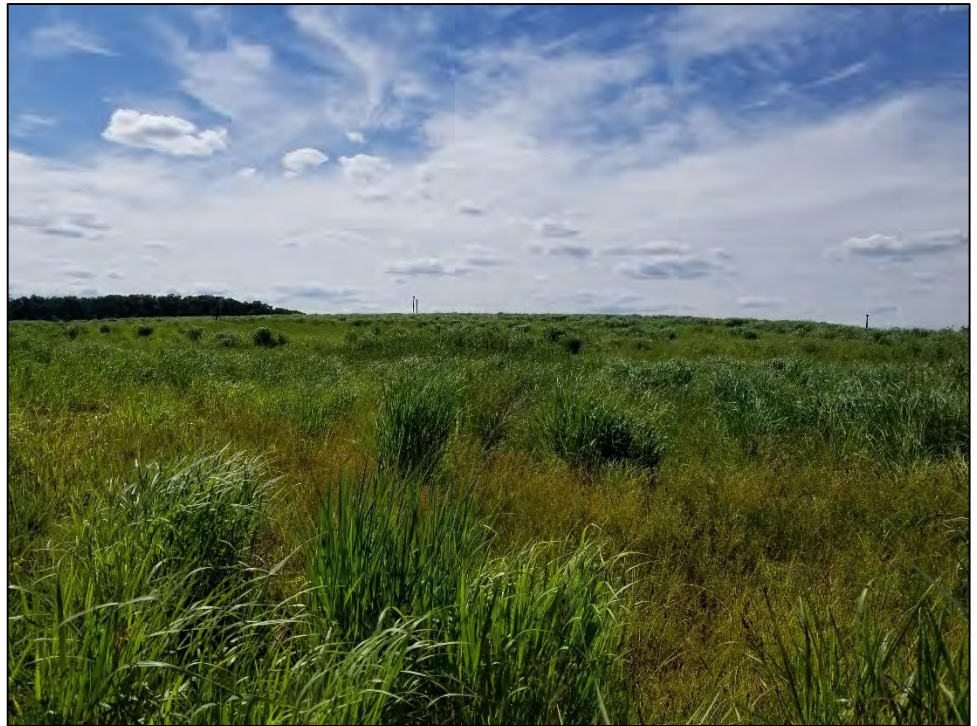
**Photo Number:** 5

**Photo Description:** Former area of standing water southeast of VB-2&3.

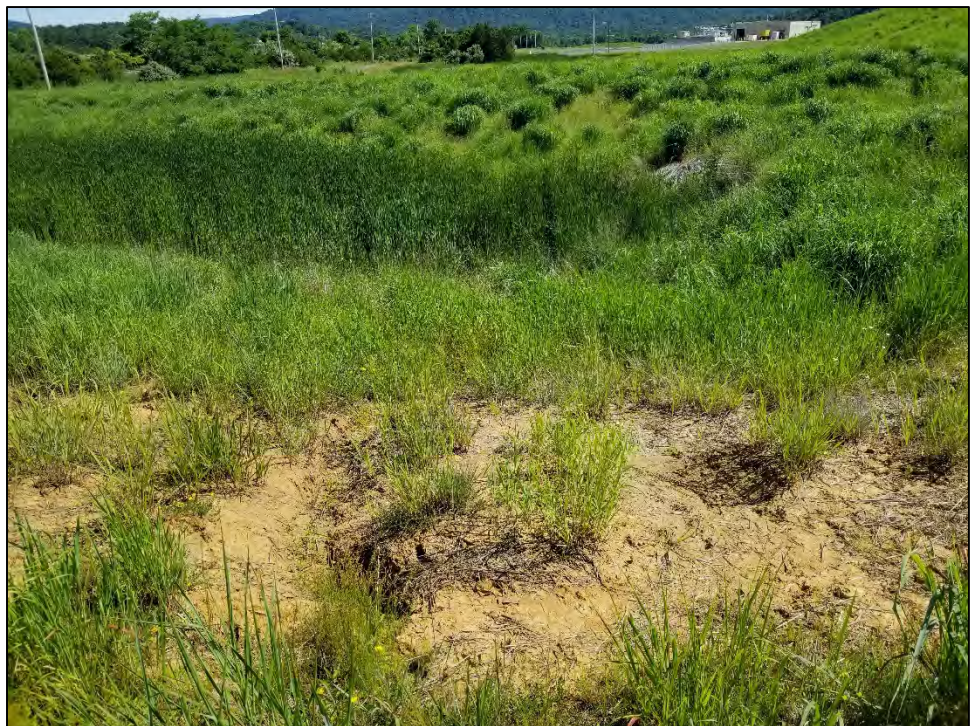
**Photo Number:** 6

**Photo Description:** Bare soil (~10' x30') with rills southeast of VB-2&3 (Sediment basin between NLF and VB-2&3). Stable.

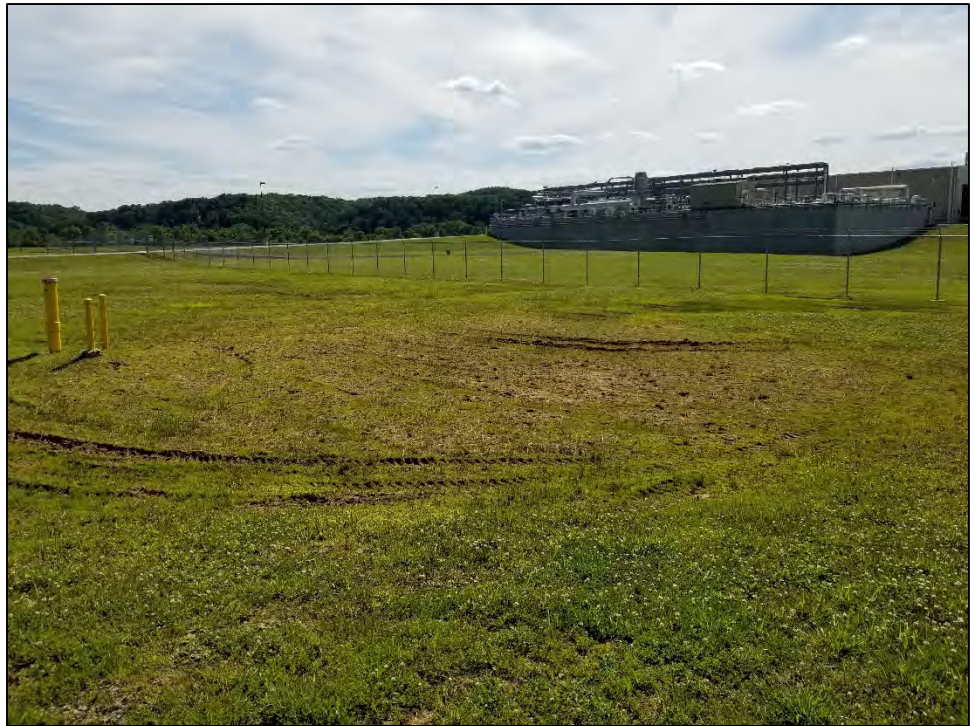
**Photo Number:** 7

**Photo Description:** Area around wells 103/203/303 drying out since well repairs.

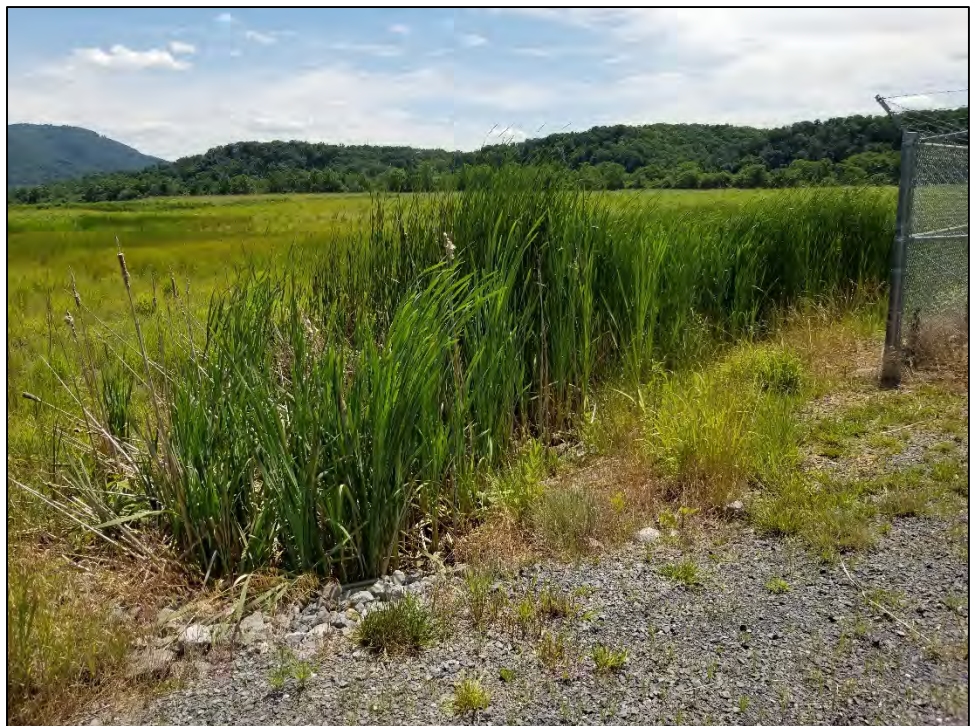
**Photo Number:** 8

**Photo Description:** Sediment building up at end of culvert under access road.

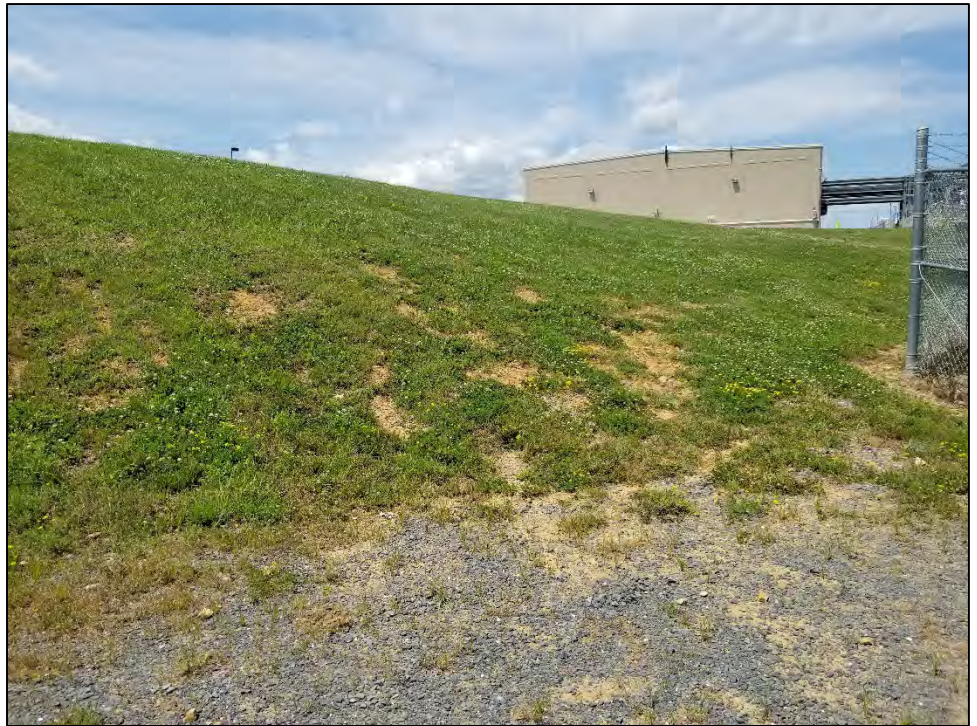
**Photo Number:** 9

**Photo Description:** Bare patches and spotty vegetation in southeast corner of VB-10. Grass is starting to fill in.

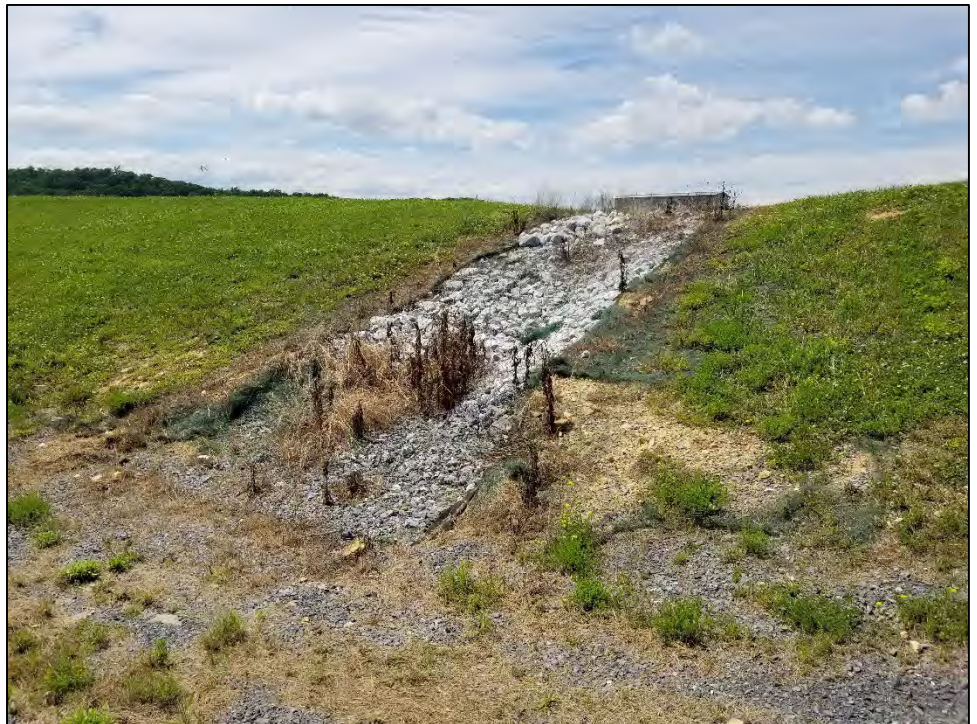
**Photo Number:** 10

**Photo Description:** Bare patches and exposed matting at down chute in south side of VB-10.

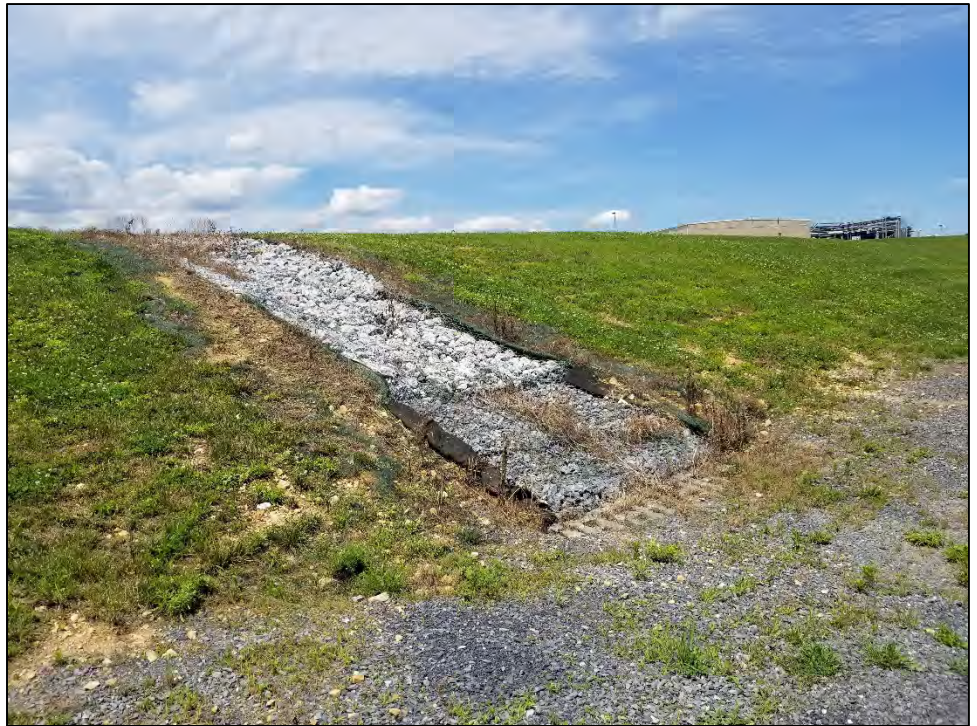
**Photo Number:** 11

**Photo Description:** Bare patches and exposed matting at down chute on south side of VB-10.

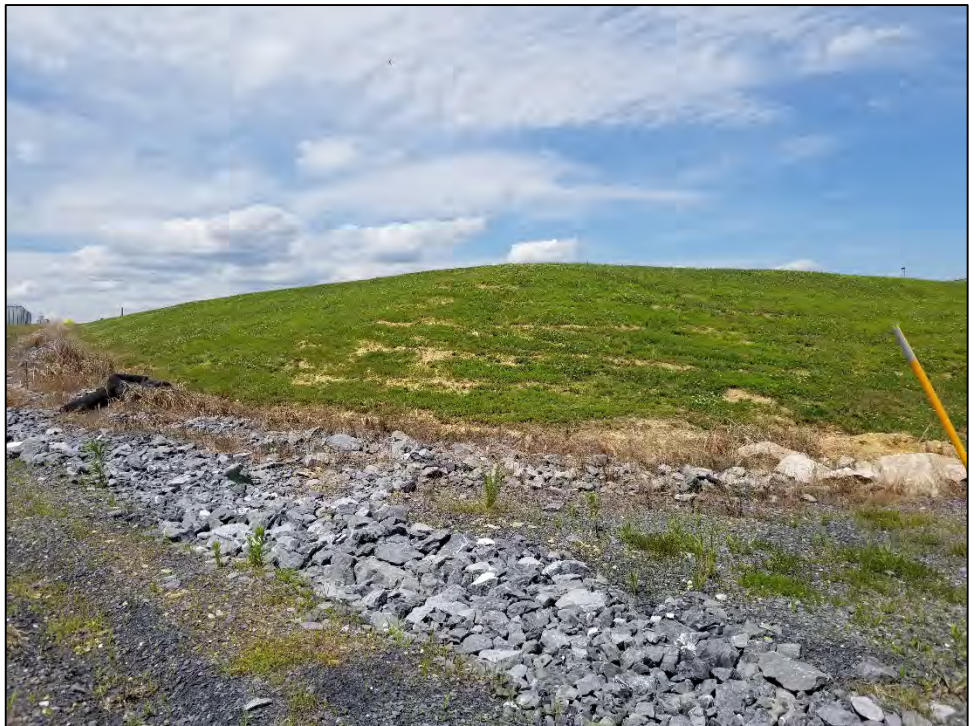
**Photo Number:** 12

**Photo Description:** Bare soil in southwest corner of VB-10. Grass beginning to fill in.

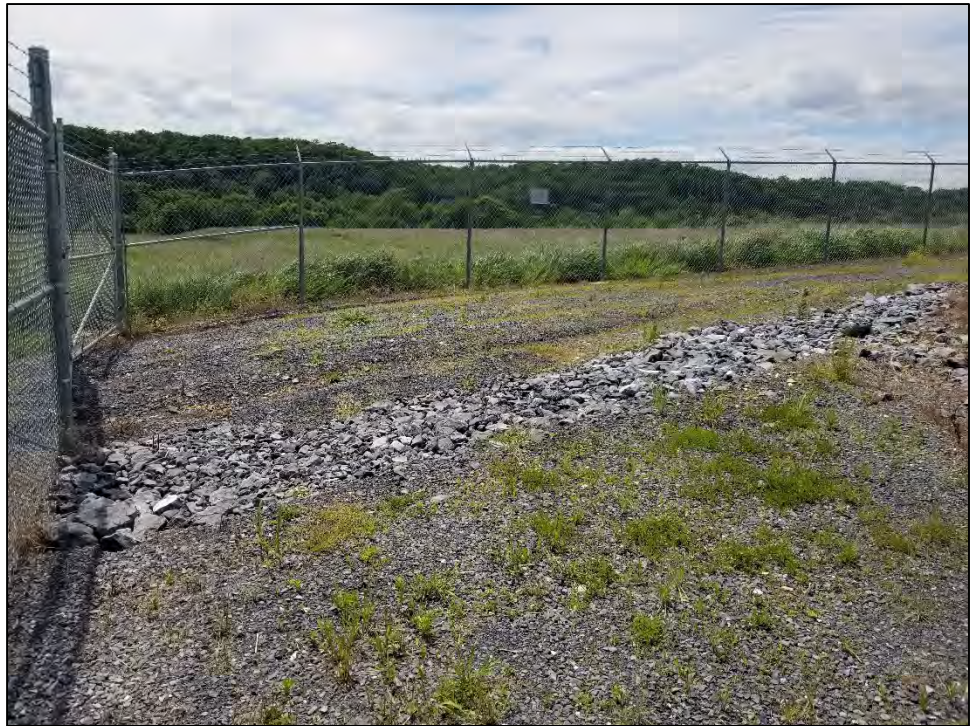
**Photo Number:** 13

**Photo Description:** Rills forming across roadway in southwest corner of VB-10 (stable).

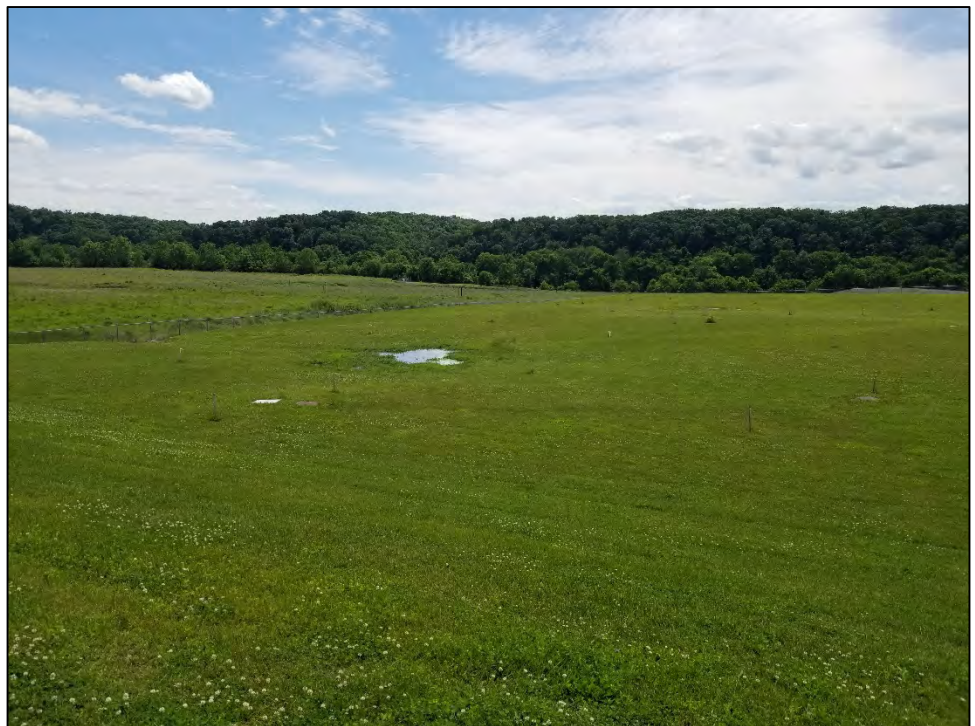
**Photo Number:** 14

**Photo Description:** Standing water in southeast section of VB-10 (30' x 30').

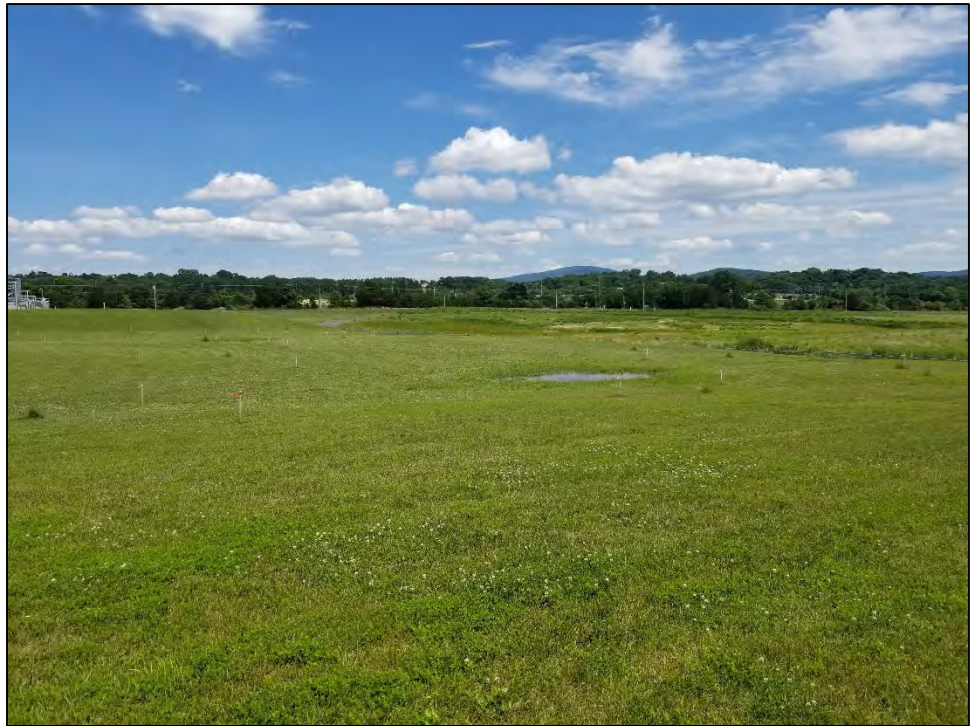
**Photo Number:** 15

**Photo Description:** Standing water in southwest section of VB-10 (30' x 30').

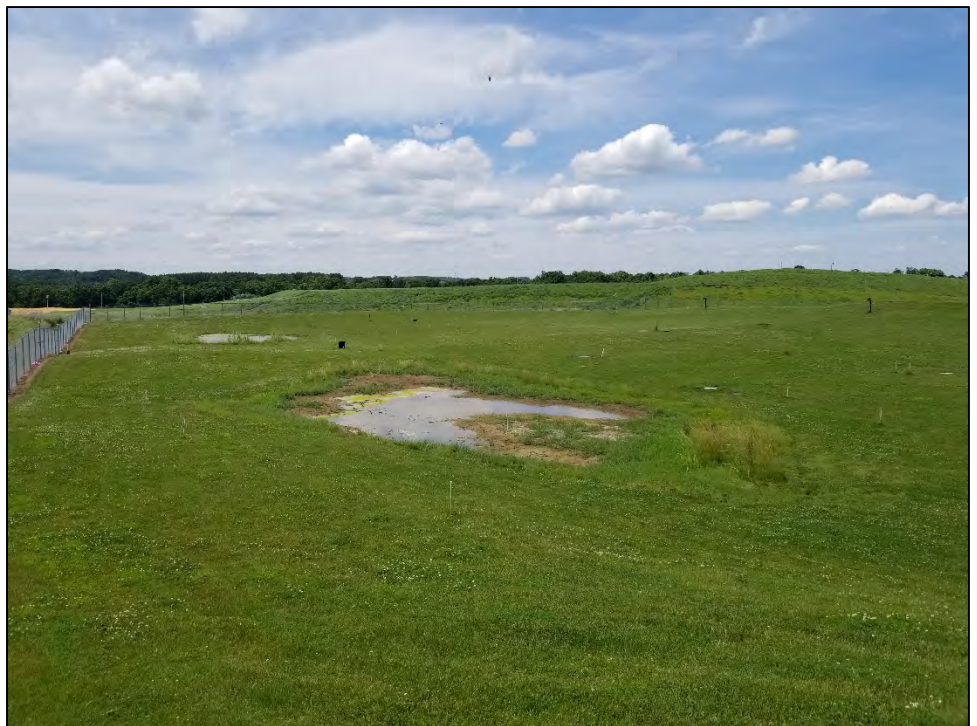
**Photo Number:** 16

**Photo Description:** Standing water and additional settlement observed to previously repaired areas of settlement on VB-9 (30' x 40 each).

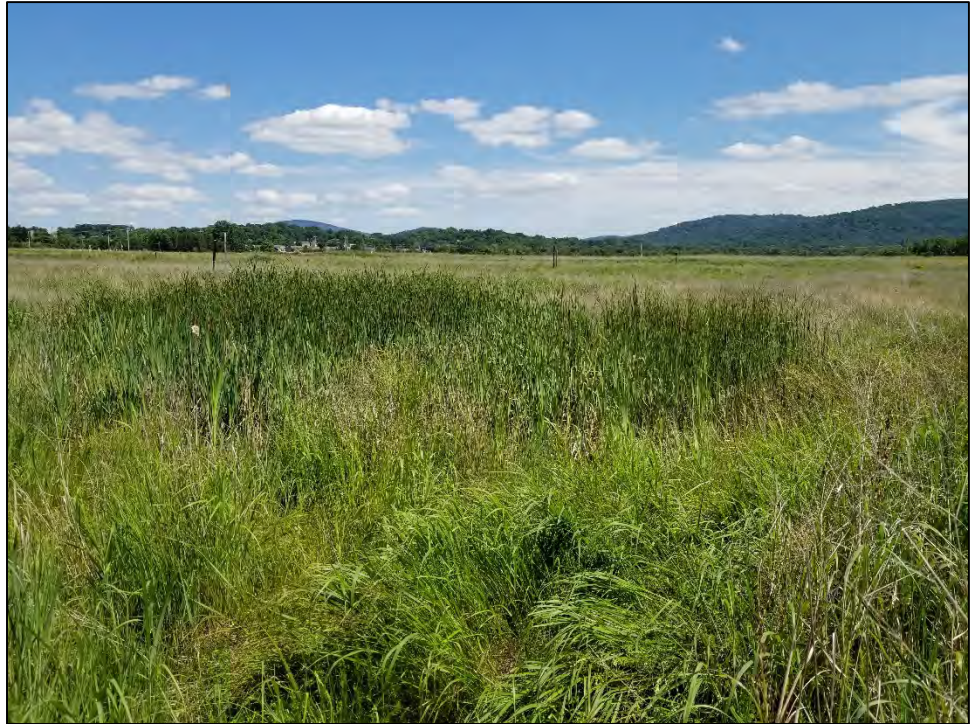
**Photo Number:** 17

**Photo Description:** Standing water (20'x40') in front of northernmost inlet between SB-3 and SB-2.

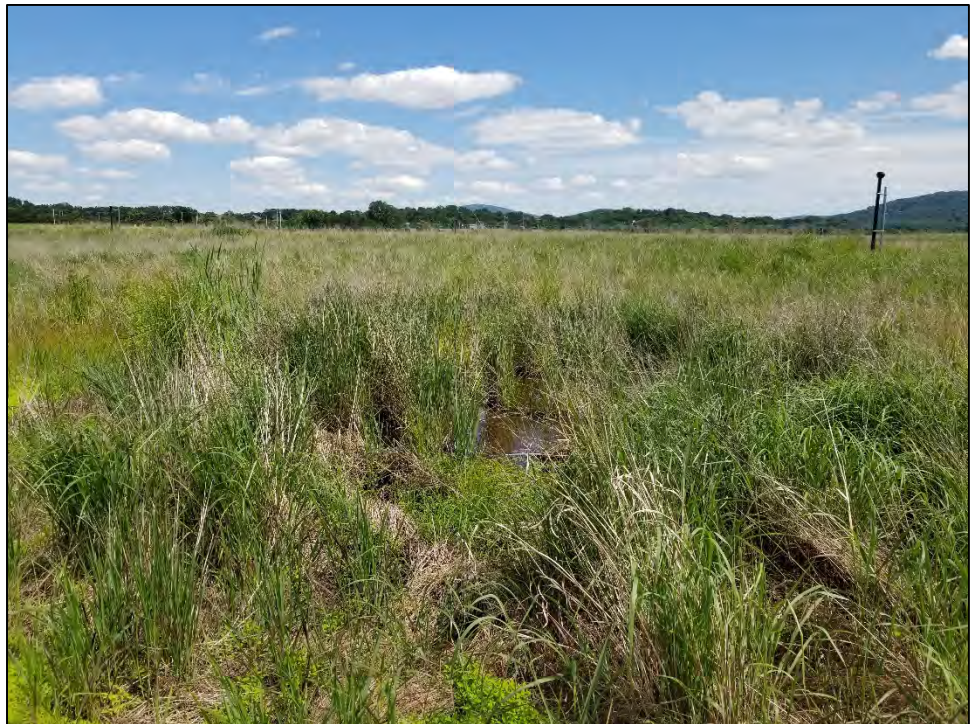
**Photo Number:** 18

**Photo Description:** Standing water (20'x20') in front of the second to northernmost inlet between SB-3 and SB-2.
